**Geological risk assessment of Amtoudi Agadir in southern Morocco:  
a key case for sustainable cultural heritage**

**Abstract** Medieval fortified granaries known as “agadirs” are very common in southern Morocco, being catalogued as world cultural heritage by UN. These Berber buildings (made of stones and tree trunks) usually located on rocky promontories, constitute historical testimonials related to the origin of Morocco and, as tourist attractions, have a positive impact on the local economy. The sustainability of these ancient monuments requires geological-risk evaluations of the massif stability under the agadir with the proposal of stabilization measures, and an architectonic analysis with appropriate maintenance of the structural elements. An interdisciplinary study including climate, seismicity, hydrology, geology, geomorphology, geotechnical surveys of the massif and diagnosis of the degradation of structural elements have been performed on the Amtoudi Agadir, selected as a case study. The main findings from this study are that the prevalent rocks used for construction (coming from the underlying substratum) are good-quality *arkosic* sandstones; the SW cliffs under the

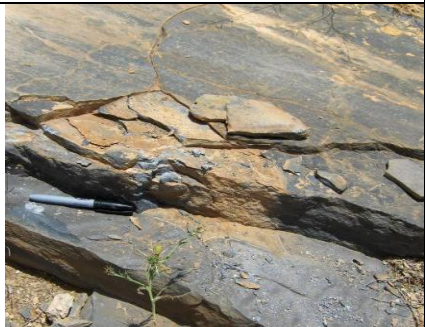
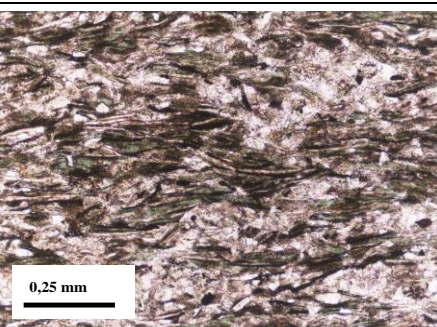
<p><b>Schist</b> (Interval D; sample 6)</p> <p>Characterized by a matrix rich in small grains of quartz and some plagioclase. The coarse fraction is composed mainly of chlorite more or less twisted and oriented parallel to the schistosity planes. Some opaque minerals (Fe-oxides and pyrite) have been also detected.</p>

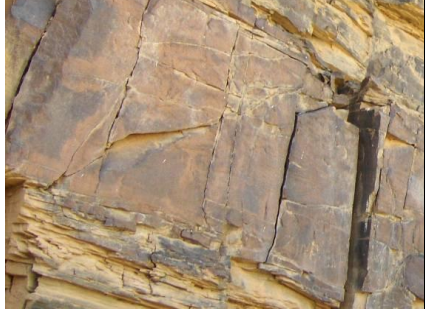
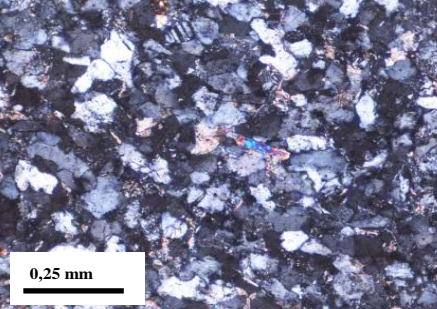
<p><b>Arkosic sandstones</b> (Intervals C and D; samples 2, 5 and 9B)</p> <p>Show mainly angular grains of quartz and minor plagioclases. In some samples mica flakes have been detected and significant amounts of opaque minerals. Carbonatic cement is found in all cases.</p>

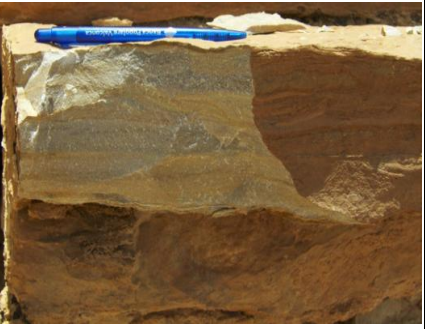
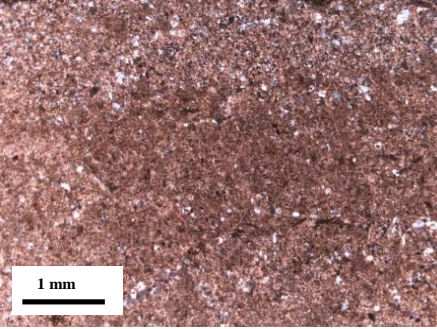
<p><b>Wackestone/Grainstone</b> (Intervals A, B and D; samples 1, 2, 4, 8, 9A, 11 and 12)</p> <p>Show a sharp petrographic variation from brownish fine-grained carbonates levels (often comprise angular grains of quartz and very rare mica flakes) to gray levels rich in grains of quartz and feldspars and traces of carbonates.</p>
